October 1957

approach

NAVAER 00-75-510

THE NAVAL AVIATION SAFETY REVIEW

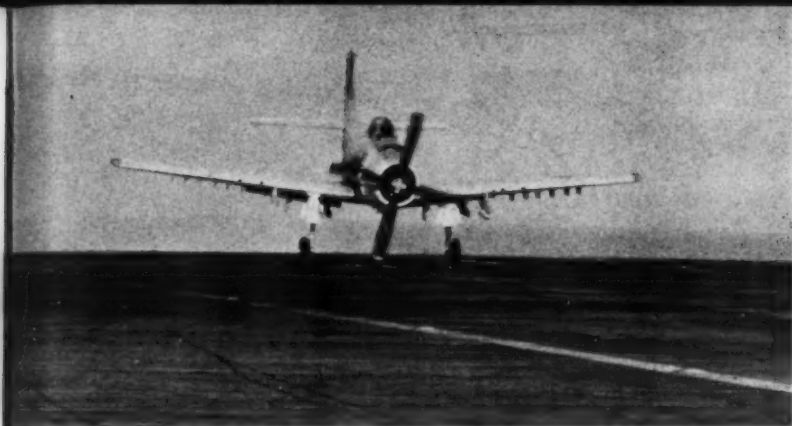
Taking a premature cut, the AD hit and bounced . . .

The accident board noted that with the canopy open, the noise level in the cockpit of the AD is such that accurate radio reception is often very difficult. The pilot was relatively inexperienced in carrier landings and was anticipating the cut and his immediate reaction to the word "Power" indicates it was either misunderstood as to intent or was not clearly received.

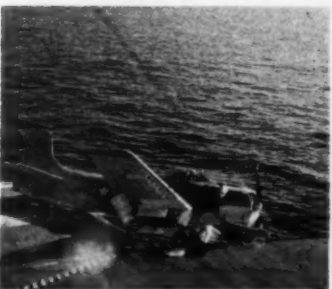
. . . minus the hook point.

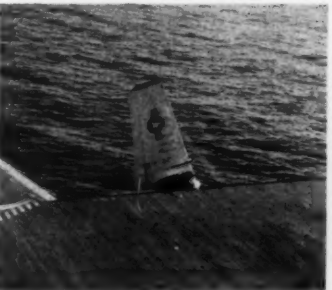
Brakes and rudder . . .

. . . failed to help.

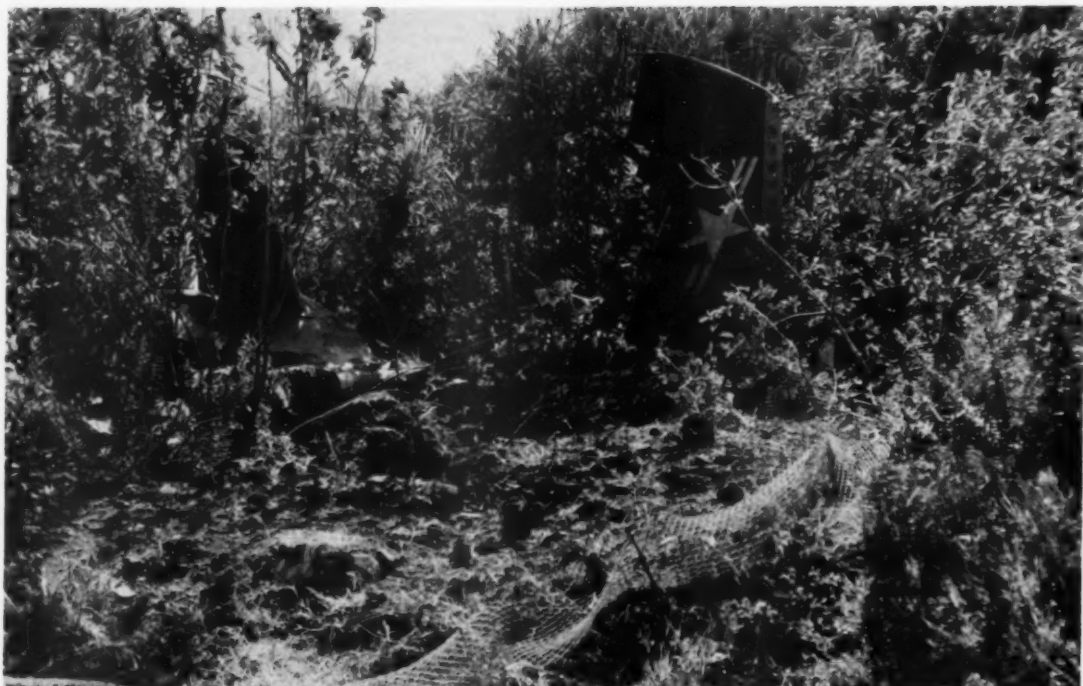
There were 4000 pounds of fuel in the tanks when the F9F-8 pilot began his approach and at this weight he was used to a longer runway than was available. To make matters worse, the runway was wet and the winds calm.

The board considered the addition of power at the 5500-foot point resulted from the pilot's striking the throttle when he reached for the landing gear control lever in his attempt to retract the gear. It was also considered that his decision to land under the existing conditions was unsound and recommended that all pilots flying the F9F-8 be required to make practice landings of varying loads on a runway of suitable length prior to attempting a landing under these conditions on shorter runways.

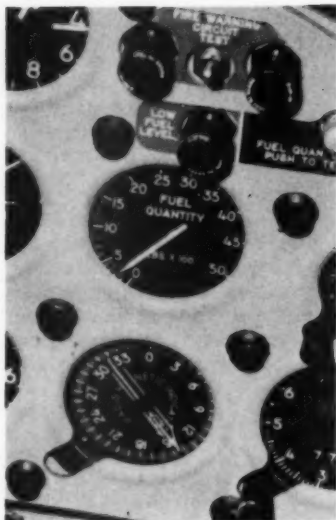
Investigation of the fuel tanks showed that all usable fuel had been consumed. The fuel quantity indicator registered 200 pounds when observed at the crash site.

All usable fuel had been consumed but the quantity indicator registered 200 pounds when observed at the crash site.

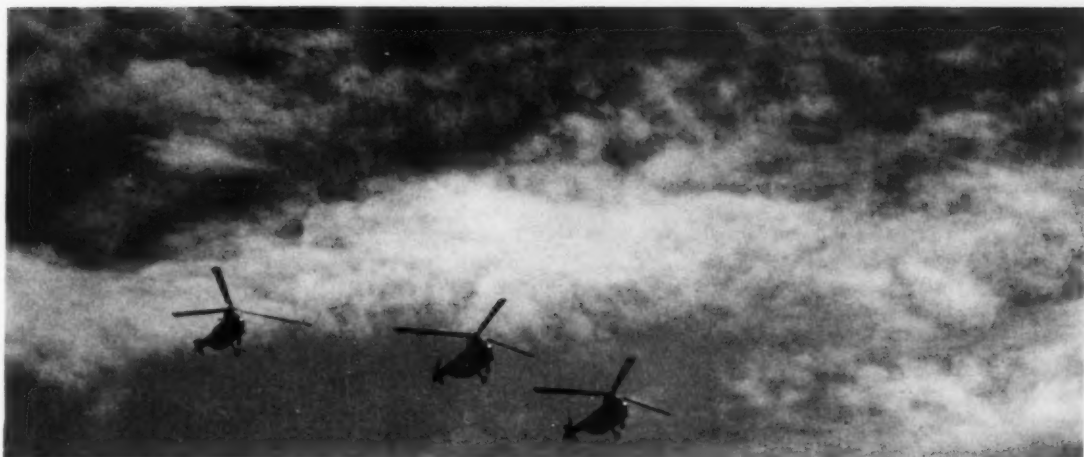
The pilots flew a loose wing position until they entered rain showers. Then the flight went into unexpected fog.

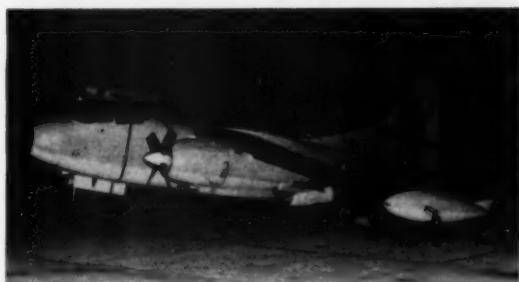
⑱. During an AJ-1 post-check, all division turnout, the left main alighting gear collapsed. The left wing of the aircraft settled immediately to the ramp causing aft lower fuselage crush damage from station 424.6 to station 538 at canted bulkhead. Sealed bulkhead at station 489 torn and crushed up to the fore and aft lower longeron. The left prop blades were sheared off at 24" from hub. Left engine sudden stoppage. Slight damage occurred to: left bomb bay door, jet access door, left tip tank, left wheelwell doors, fairing at wing root of left wing.

⑲. An investigation disclosed that this accident was caused by (1) landing gear safety pin, on which the spring locking mechanism was broken off, and (2) the inadvertent operation of the landing gear Weston valve.

The landing gear pin was observed to be installed prior to turnout. However, the subsequent prop wash, in the wheelwell, acting on the warning ribbon dislodged the pin. The Weston valve was inadvertently operated by the maintenance personnel while investigating inoperative flaps. The physical location of the Weston valves is a confined area and the proximity of the landing gear valve to the flap valve is well within the span of the normal hand. The electrician did not visually observe the position of his hand on the Weston valve panel during the valve operation.
